Amerock Turn-A-Shelf (“Pie Cut” revolving Shelf for corner cabinets)

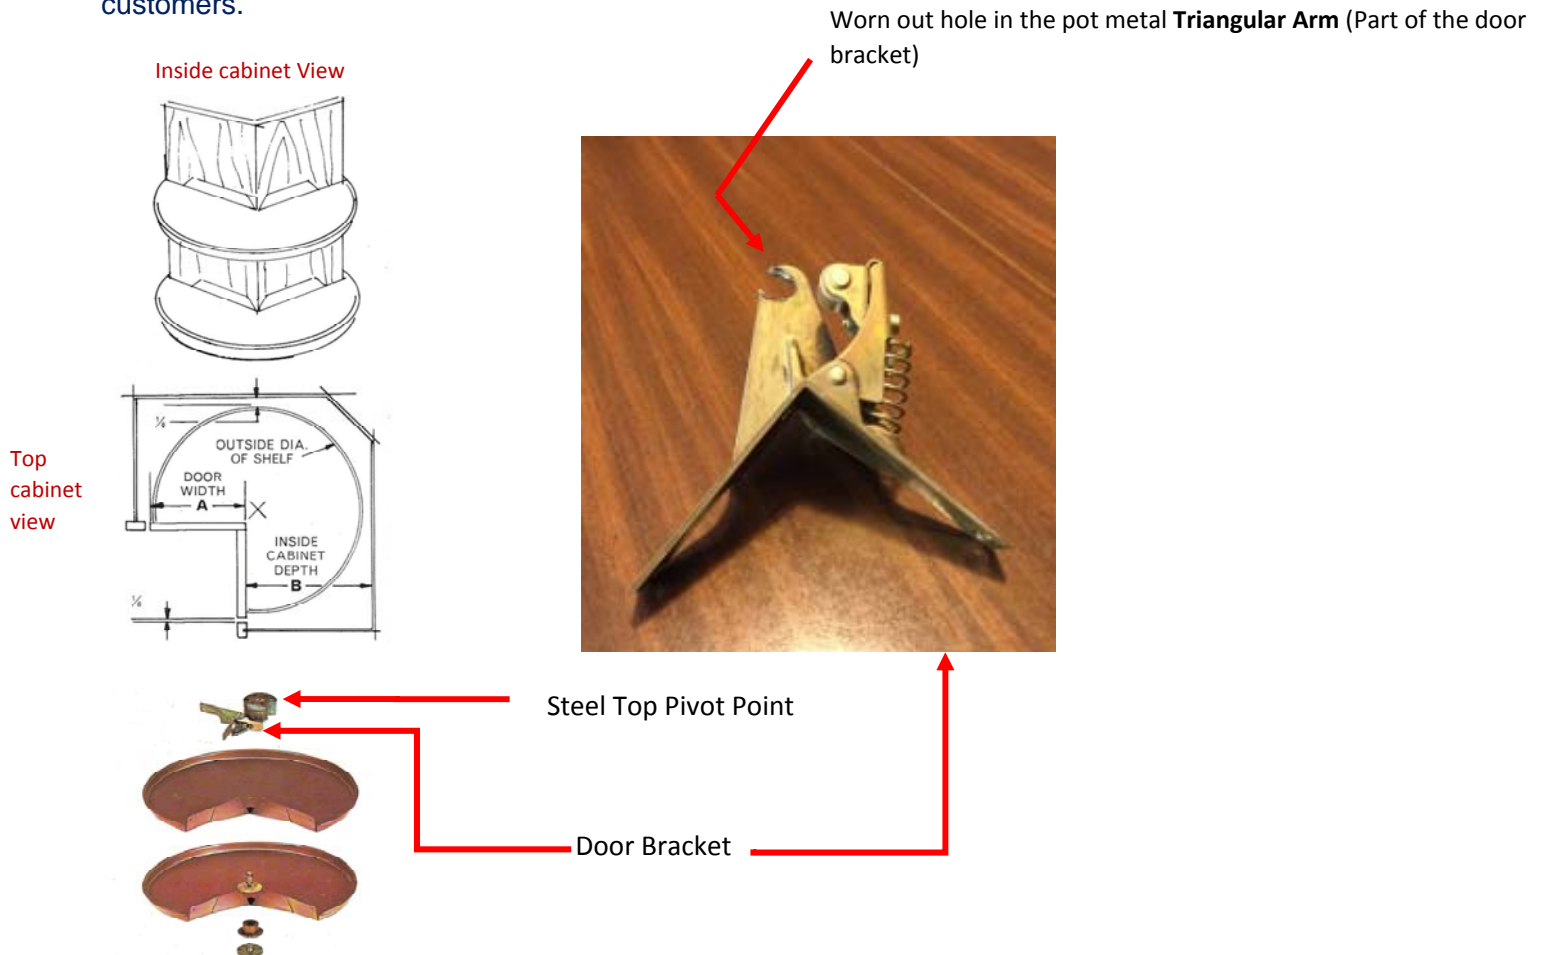
The most common problem is that the steel top pivot pin (in the top pivot) is much stronger than the hole at the end of the zinc/pot metal triangular arm coming off of the door bracket. The steel pin wins the battle. (See picture below).

I have developed a custom repair kit for this problem. I call it **Stan’s Pie Cut FIX-IT-KIT**. You do need to keep your old door bracket as you will be reusing most of it in your re-build.

- A custom manufactured steel plate that conforms to the shape of the arm coming off of the door bracket
- Instructions, a paper template for the repair, and line art drawings showing component parts

Tools needed: A vise to hold the bracket while you repair it. A hack saw to cut off the old hole (after gluing or pasting down the paper template from the instructions), an electric drill or hand drill for drilling 3 new holes using the three holes already drilled thru the steel plate as drilling guides, pliers or wrench, a screwdriver, and some Loctite. All nuts and bolts are provided in the kit.
